Stork Herron Testing Laboratories

Test Report No.: COR001-09-12-94129-1

Material Testing and Non-Destructive Testing

TEST REPORT

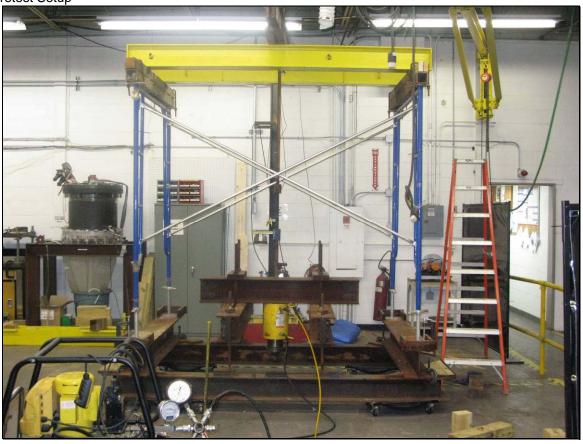
Pretest Setup

- Arch Scaffolding Results

Scaffolding Type	Maximum Load (lbs)	Failure Location
Arch	39130	Arch Bend

Testing followed the general procedures outlined in section 5.2 of ANSI ANSI/SSFI SC100-5/05 except the scaffold assemblies were only one tier high and only one of each type was tested.

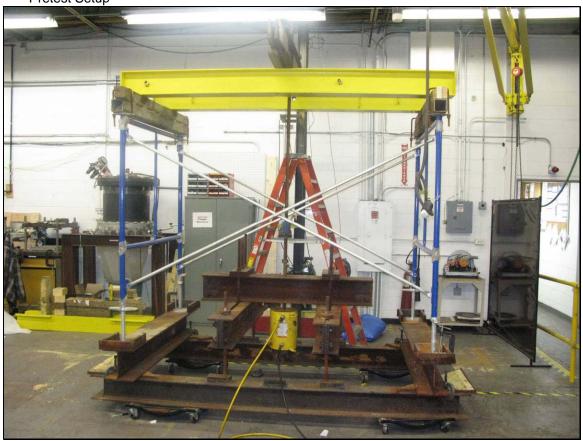
Pretest Setup

- Ladder Scaffolding Results

Scaffolding Type	Maximum Load (lbs)	Failure Location
Ladder	52075	Arch Bend

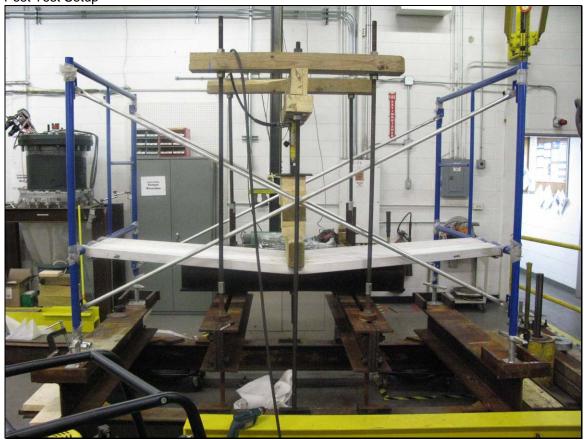
Post Test Setup

- Concentrated Load Test

Sample is restrained on the ends with load applied to the center,

Test Type	Load @ 1.6" Movement (lbs)	Failure Location
Concentrated	2300	Center at L/60

Walkways had dimensions of 19 $\frac{1}{4}$ " x 8' giving a surface area of 12.8 ft². All samples were stamped with a load rating of 75 lbs / ft². All samples were loaded until a displacement of L / 60 or 96" / 60 = 1.6" occured.

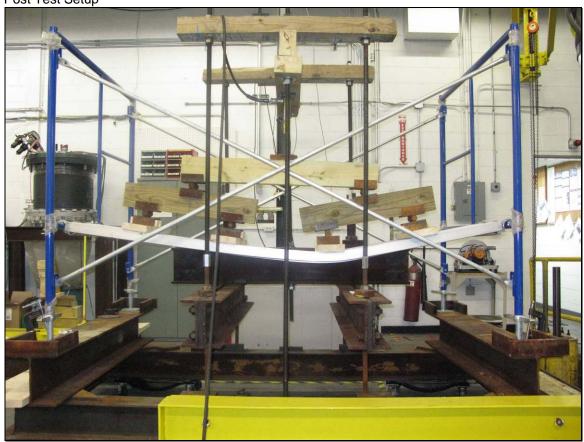
Post Test Setup

- UDL Load Testing

Sample is restrained on the ends with four load points evenly distributed across the walkway surface.

Test Type	Load @ 1.6" Movement (lbs)	Failure Location
Concentrated	1600	Near Center at L/60

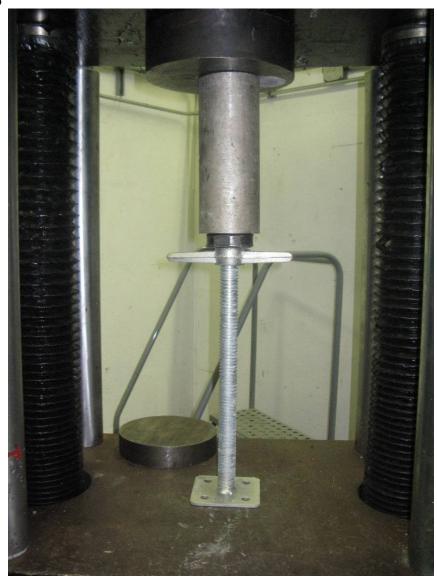
Pretest Setup

Jack Screws were compressed at two different screw extensions until failure.

Screw Extension Length (in)	Load @ Failure (lbs)	Failure Type
12	57000	Buckle
18 ¾	53000	Buckle

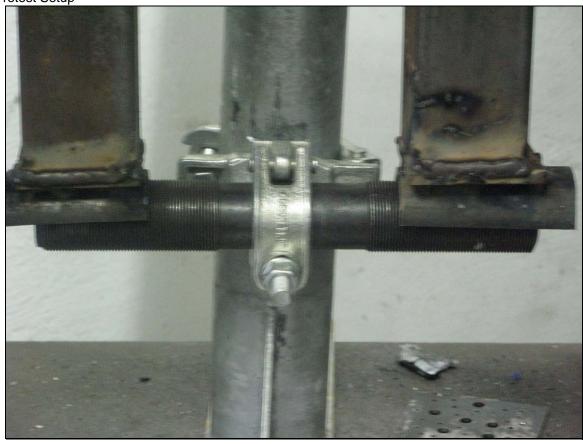
Pretest Setup

Couple testing followed the procedures outlined in section 5.1.3.1 of ANSI ANSI/SSFI SC100-5/05.

Couple Type	Load @ ¼" Slip (lbs)	Tube Type
Rigid	1988	3 1/2" Shore Post
Swivel	4420	3 1/2" Shore Post

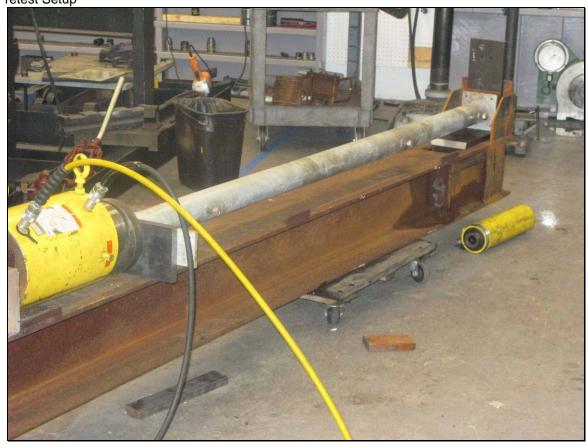
Pretest Setup

Shore post was compressed until failure.

Product	Maximum Load (lbs)	Failure Type
3 1/2" OD x 8' Length	85000	Buckle

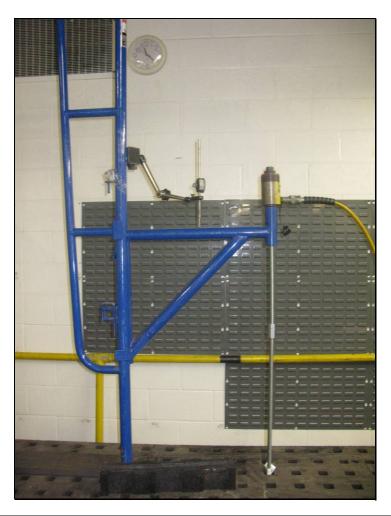
Pretest Setup

Ledger testing generally followed the test procedure outlines in section 14.3 of ANSI/ASSE A10.8-2001 with the exception that only a single Ledger was tested.

Product	Load @ Deformation (lbs)	Failure Type
Ledger	2900	Ladder Frame Deformation
