REPORT NO: MT-13/037-C

TESTING OF CORONET LOAD BEARING SCAFFOLD COMPONENTSCLIENT: CORONET SCAFFOLD GROUP SUZHOU CO., LTD
SIFC SIP, SUZHOU CITY
JIANGSU PROVINCE, CHINA
P: +86-512-85557000 F: +86-512-85557111DATE OF TEST: JUNE 5TH – JUNE 12TH 2013DATE OF REPORT: JUNE 17TH 2013**TEST SYNOPSIS:**

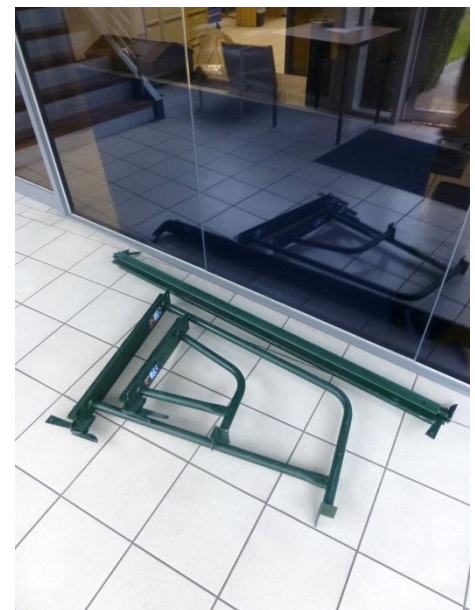
**FIG.1
LOAD BEARING COMPONENTS**

A consignment of Coronet load bearing scaffold components were delivered to the MTS laboratory for load testing (see Fig.1). At the request of the client, the test items were to be tested in accordance with AS/NZS 1576.3:1995 - APPENDIX C in conjunction with AS/NZS 1576.1:2010 SCAFFOLDING PART 1: GENERAL REQUIREMENTS, to determine the compliance of each load bearing component with the aforementioned standards.

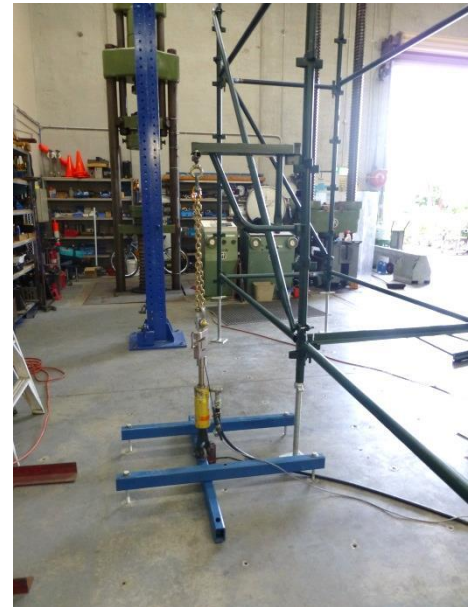
**FIG.2
3 BOARD HOP-UP TEST SETUP**

The calculated test load for each bracket was applied as a concentrated point load at the tie bar connection points (see Fig.2).

- Recorded deflection at peak test load: 47mm
- Residual deflection upon removal of the test load: 9mm
- No visible sign of failure observed either during or at completion of testing.

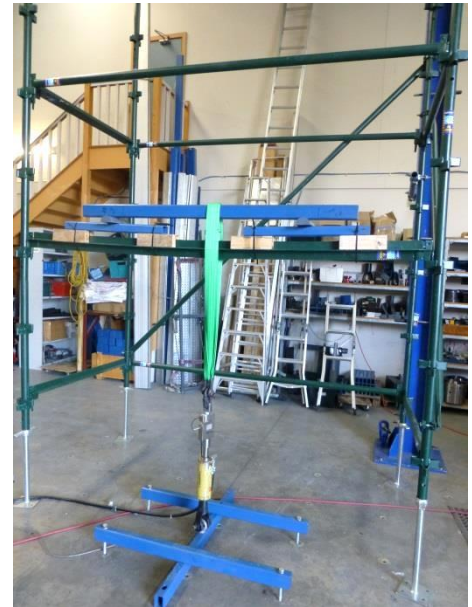
FIG.4
2.4M TRANSOM TEST SETUP

The test force was applied using a simulated UDL, four point articulated loading arrangement (see Fig.4). The force was applied using loading platens with a nominal width of a scaffold plank (≈230mm) (see Fig.4).

- Recorded deflection at peak test load: 30mm
- Residual deflection upon removal of the test load: 7mm
- No visible sign of failure observed either during or at the completion of testing.
- Post-test residual deformation was observed. However, the 2.4m transom was deemed structurally serviceable at the completion of testing.

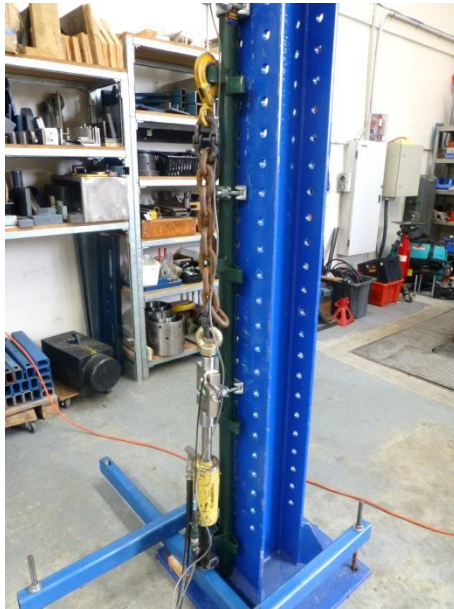
**FIG.5
V-PRESSING TEST SETUP**

The scaffold standard’s V-pressings were load tested to ascertain the mechanical strength of the connection. The test force was applied at the outermost edge of the V-pressing in order to simulate the most adverse service condition (see Fig.5).

The test force was progressively applied until failure of the V-Pressing was visually evident. Throughout each test, calibrated laboratory displacement devices were utilized to record the displacement at the outermost edge of the V-Pressing.

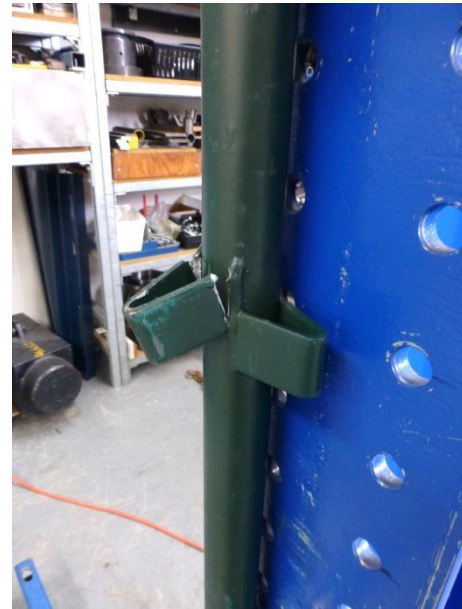
**FIG.6
FAILURE OF V-PRESSING**

In all three (3) tests, failure of the standard’s V-pressing was characterized by vertical plain rupture of the welded connection (see Fig.6).

A total of three (3) tests were performed in order to ascertain the mean strength of the welded connection. The mean strength of the scaffolding standard’s V-pressing welded connection was **34.2kN ≈ 3489kg**.

As described and reported herein, the load tests confirm that a Coronet standard's V-pressing has an Ultimate, Vertical Load Capacity of **34.2kN \approx 3489KG**. MTS advises that this load is the destructive load capacity and it should not be taken to imply safe working load or working load limit. The data as presented for the V-pressing is deemed experimental and is not normally required for testing in accordance with AS/NZS 1576. With this in mind, engineers or designers intending to utilise the V-pressing load capacity should apply rigorous analysis and engineering diligence to ensure the appropriate capacity reduction factors are applied.
